First, I do want to say that Thermography **IS NOT** the end all and be all that many would like you to believe. The thermal imager (thermal camera as it is more commonly called) is just another tool that can help the Inspector find additional issues they might not catch with a visual only inspection. Thermography can do this with greater accuracy and ease as well. However, the thermal imager **IS NOT** a substitute for a good set of senses and other actions that should be taken; regardless if thermal imaging is used or not. The imager only detects anomalies that must still be checked/verified using other means such as moisture meters for water issues, thermometers for insulation issues, along with other conditions and tools, and above all, the eyes and brain of the Home Inspector! Some anomalies will still defy explanation with secondary means and must be left to destructive inspection/testing that are not a part of a normal home inspection.

Below are wonderful examples of thermal images taken from home inspections.

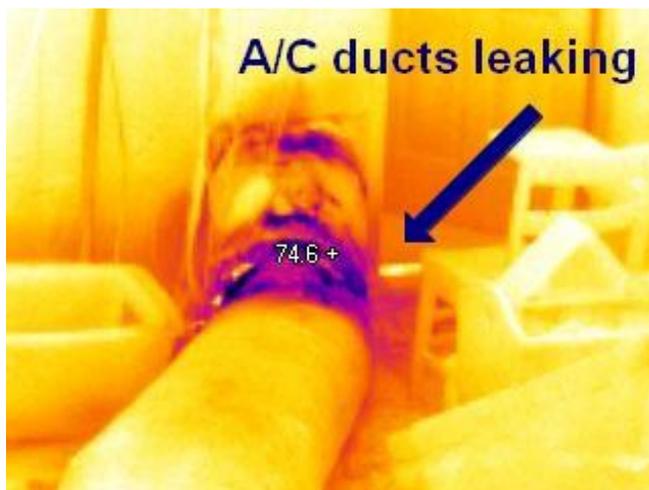
A/C duct leaking. Invisible to the naked eye.

4. It can be used to quickly find HVAC (heating/cooling) ductwork leakage, not only with exposed ducts in attics, but in the enclosed walls and ceilings as well.

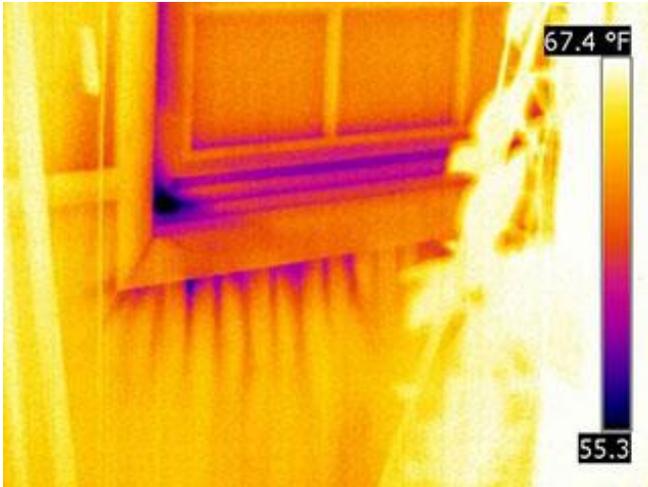
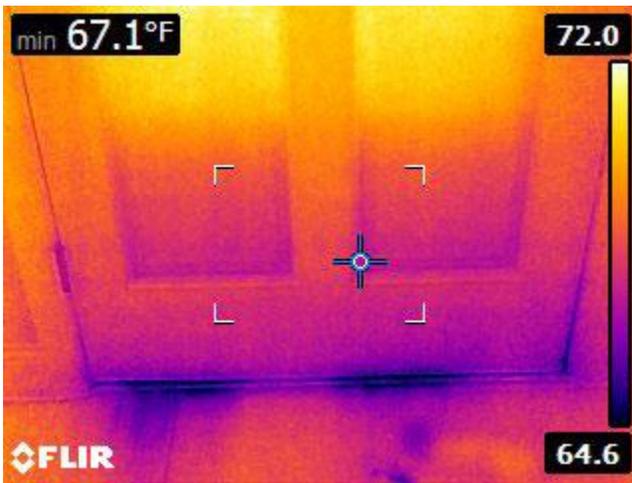
Cold air infiltrating at window casing trim and door threshold (below). *Invisible to the naked eye.*

5. It can be used to help quickly find air infiltration points around virtually any opening in the home, not just windows and doors.

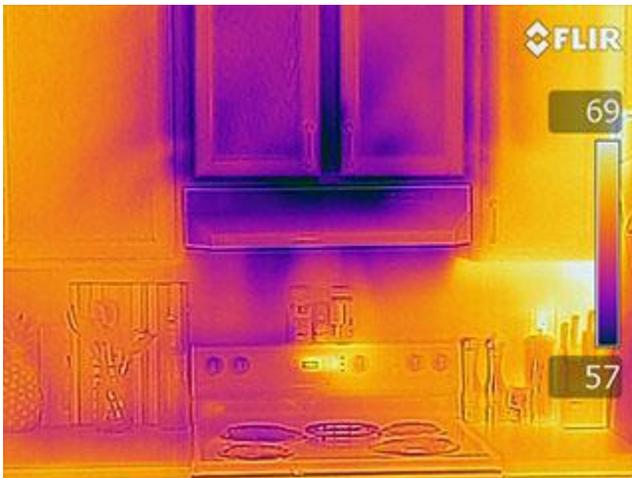
Cold air infiltration from the exhaust duct.

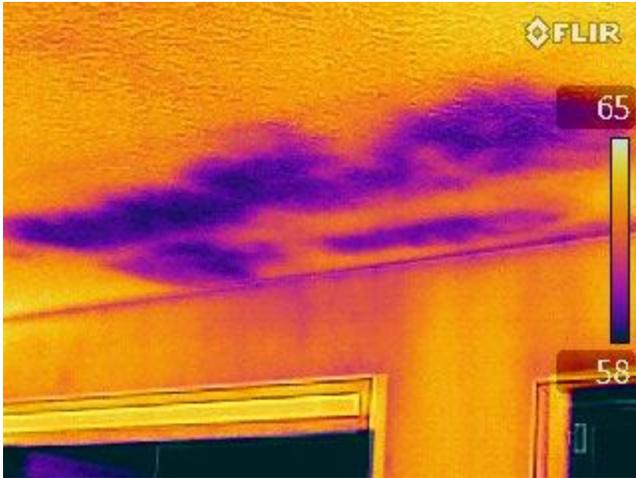
Water leak. *Invisible to the naked eye.*

3. It can be used to detect plumbing leaks as well as leaks in the home's outer envelope where rain might be entering. Even if you do not receive a lot of rain, plumbing leaks can happen. You might not be able to visually see a slow plumbing leak but thermal imaging can catch it when properly performed.

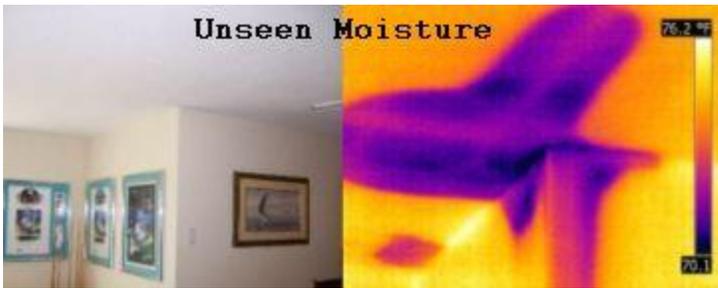
Moisture infiltration. *Invisible to the naked eye.*

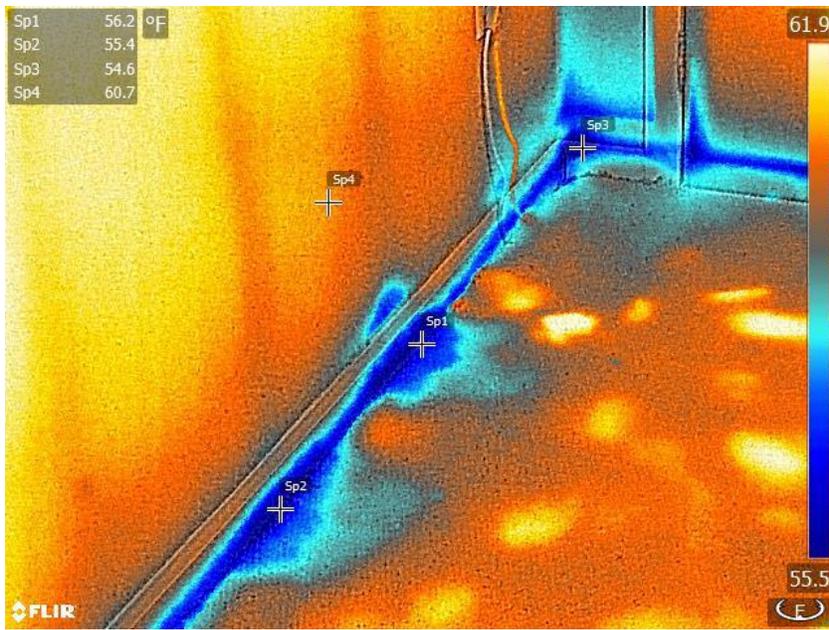
Moisture infiltration.

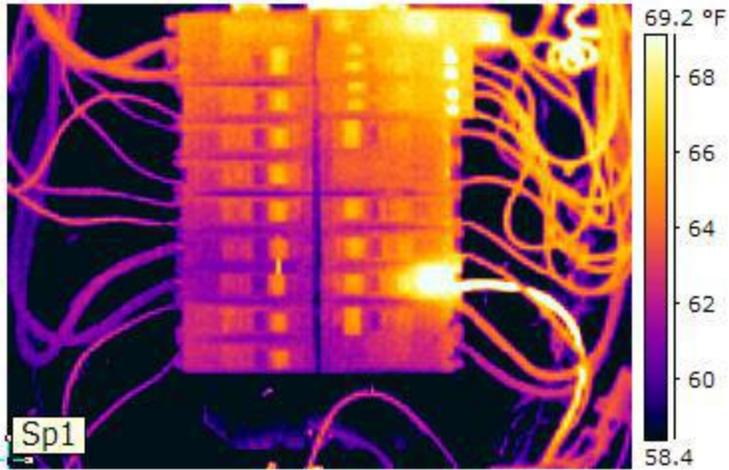
Possible overheated circuit breaker. *Invisible to the naked eye.*

1. Electrical issues, such as loose connections in electrical panels, switches and outlets and other electrical problems. The caveat with this though, is that to find these issues you must have current flowing to/through the device and wiring being checked. In other words, an electrical outlet that has loose connections with nothing plugged in and drawing current through it leaves nothing to be discovered.

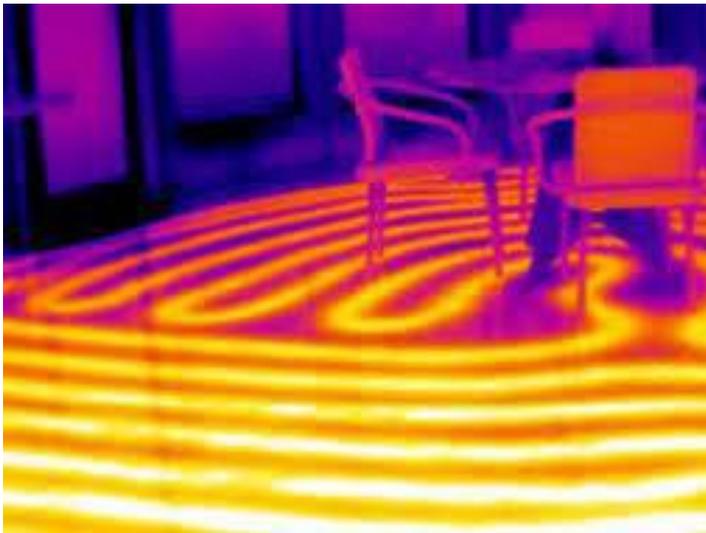
Clearly see floor radiant heating elements or piping. *Invisible to the naked eye.*

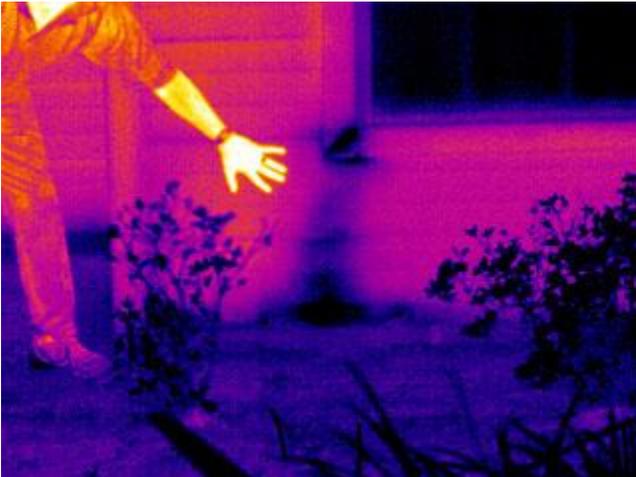
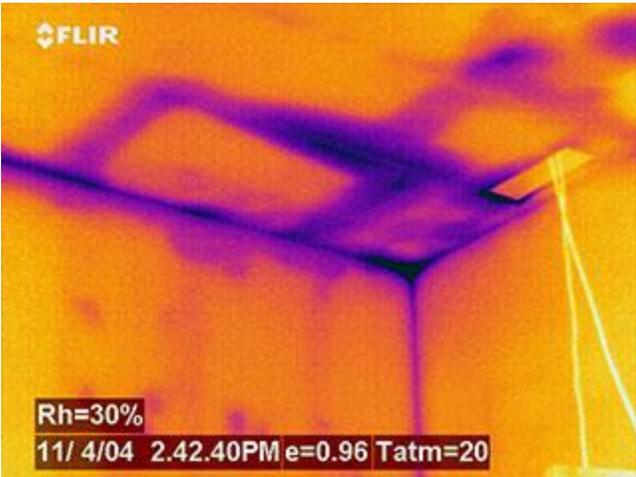
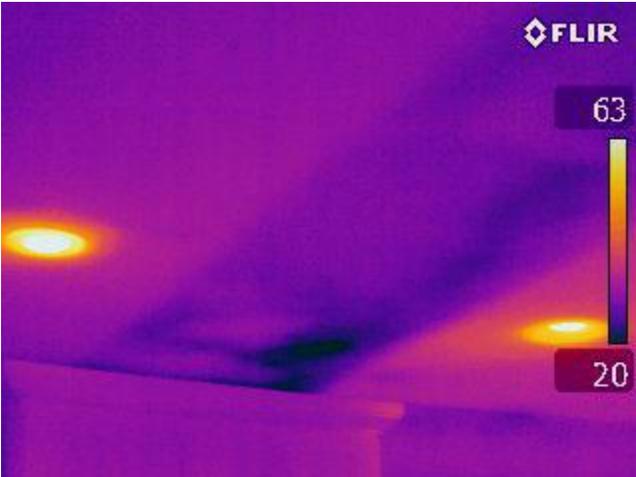
Still more evidence of moisture...

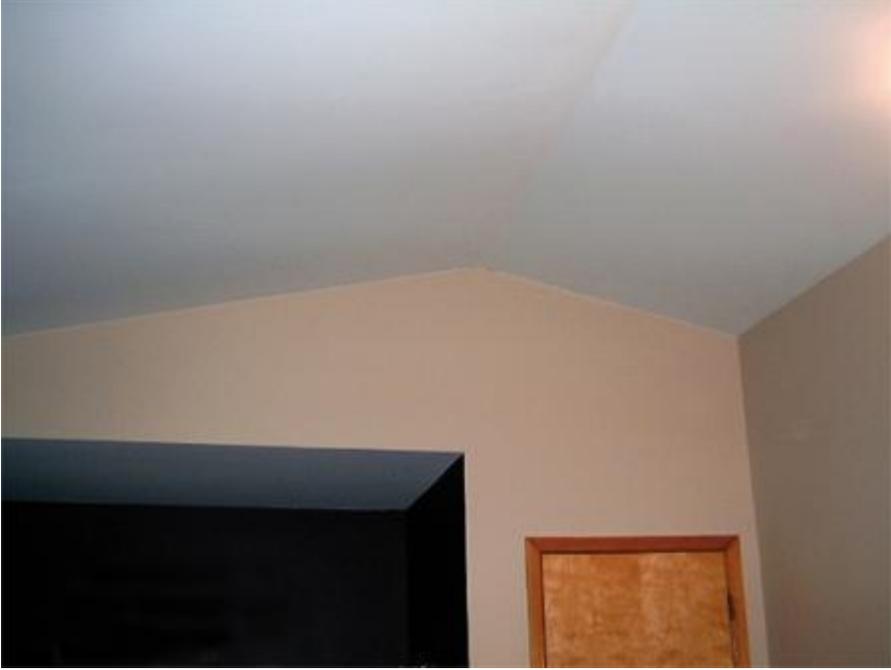
Missing insulation in cathedral wall.

2. Insulation deficiencies in walls and ceilings. The caveat here is that Thermography can not tell you what the "R-Value" is or how much of a drop it is for the insulation deficiency. In enclosed walls it can identify those missing or disrupted insulation areas that can cause significant cold/hot spots. The imager does not replace a proper attic walk that might have found the missing or disrupted insulation to begin with.

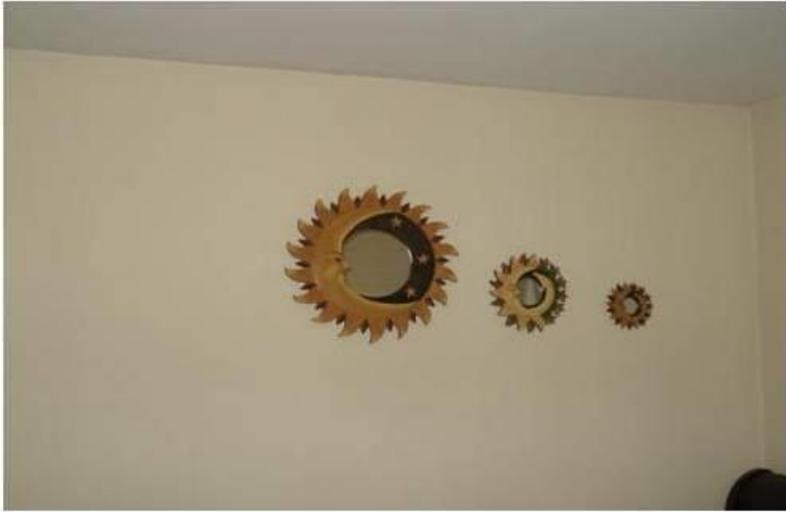
Missing insulation between wall stud.

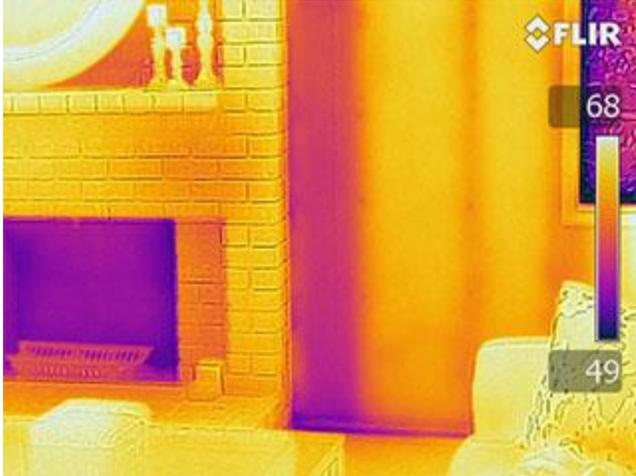
Missing and displaced insulation. *Invisible to the naked eye.*

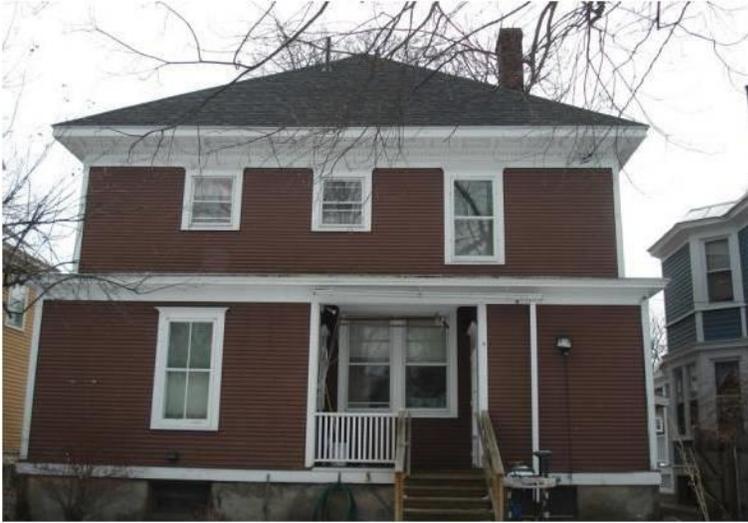
More missing insulation. *Invisible to the naked eye.*
